Suppl. Decl. of B. Zigler, 11/12/24

Supplemental Declaration of Dr. Bradley Zigler

November 12, 2024

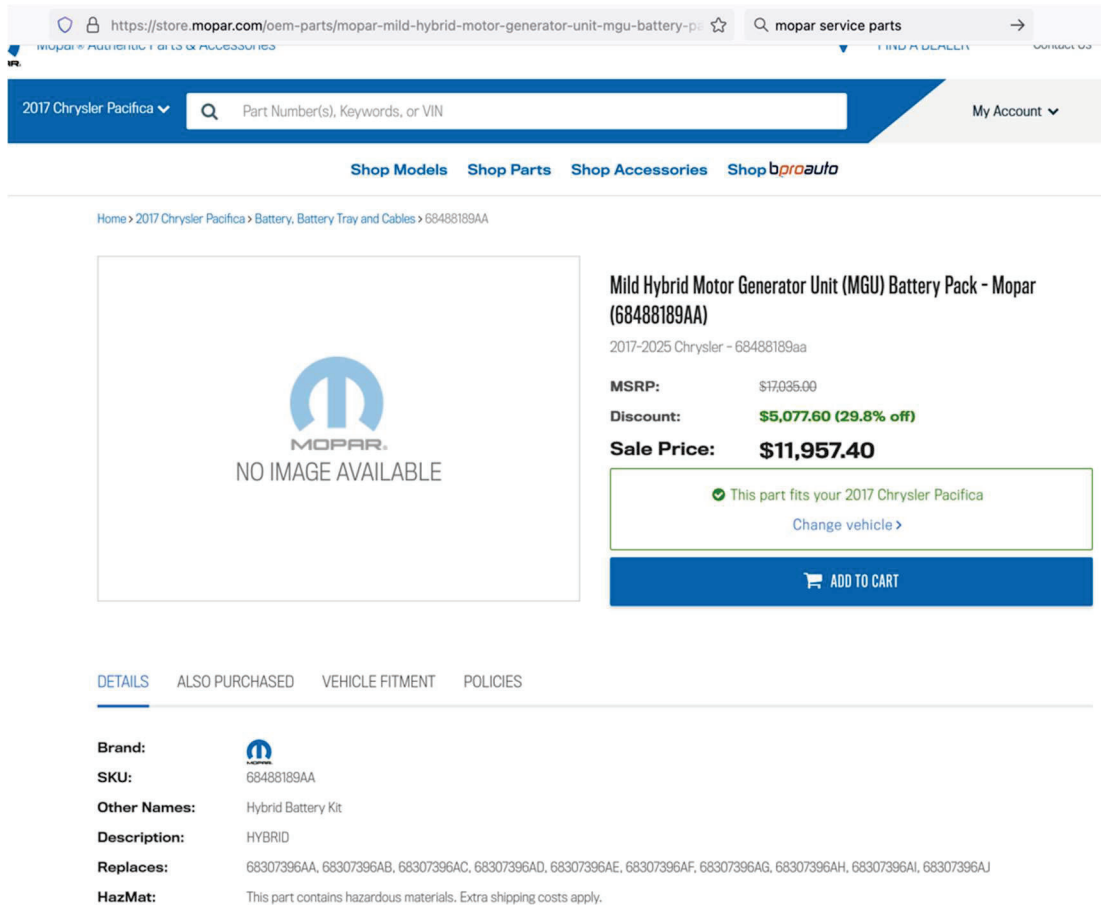
Figure 3. Mopar website screenshot for the HV battery pack service part.⁹

As I previously opined, a single HV battery kit service part (SKU: 68488189AA), is compatible with all Class Vehicles. To date, FCA's original equipment manufacturer Mopar still lists the 68488189AA Hybrid Battery Kit service part as the replacement part for MY2017-MY2025 Pacifica Hybrid vehicles (Figure 3).

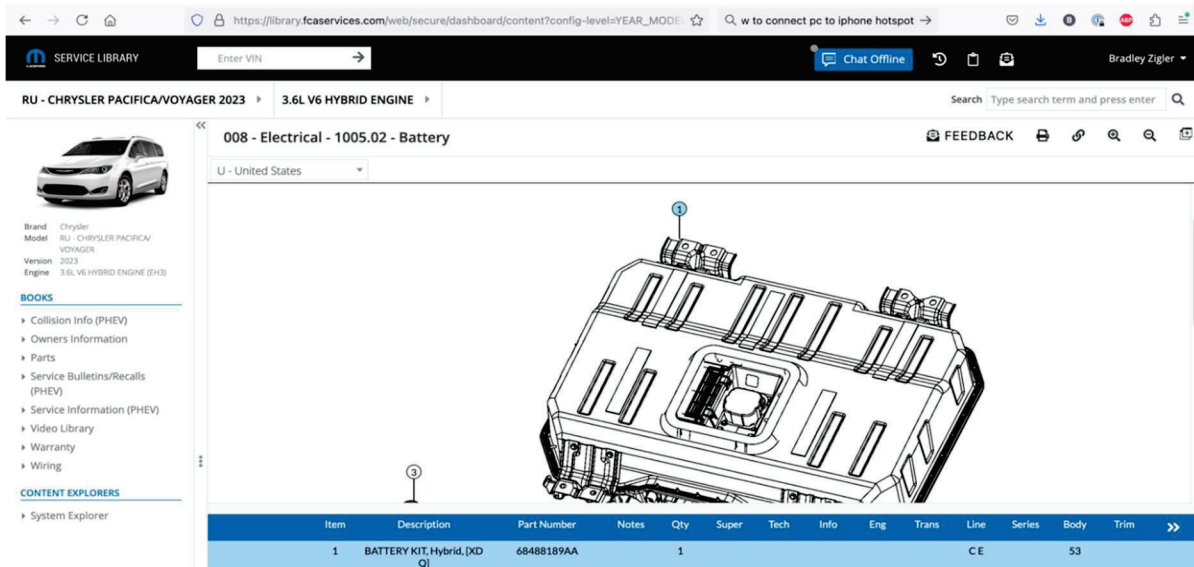
Figure 6. OEM subscription service portal information for MY2023 Pacifica Hybrid Battery Kit.

The HV battery kit part numbers for MY2017 and MY2018 are 68307396AA and 68307396AH, respectively, while the HV battery kit part number for MY2023 is 68488189AA. Even though the part numbers differ between the model years, the current service part number 68488189AA replaces a number of prior versions, including 68307396AA and 68307396AH (the HV battery kit for MY2017 and MY2018), and matches the service part number for the MY2023 (Figure 3). This confirms the 68488189AA service part is backward compatible for form, fit, and function to service MY2017-2018 Pacifica PHEVs.

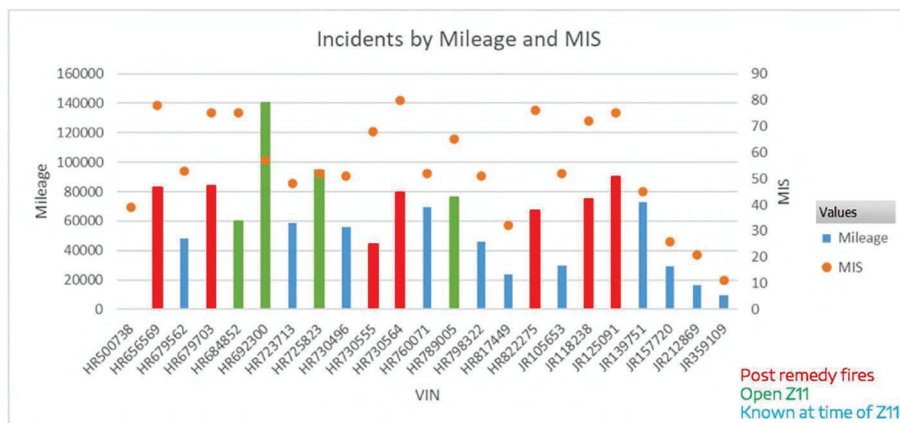
Figure 14. FCA analysis of first 23 fire incidents.³⁹

FCA's analysis of 23 Class Vehicles fires (as of May 22, 2024), showed the Vehicles' average time in service (TIS) was 4.5 years and the average mileage was 61,000, as shown in Figure 14.³⁸

- 23 total incidents of fires originating from the HV battery
- 11 fires received since Z11, with 7 of those occurring after the remedy was completed
- Average TIS of failures: 4.5 years
- Average mileage of failures: 61,000 miles

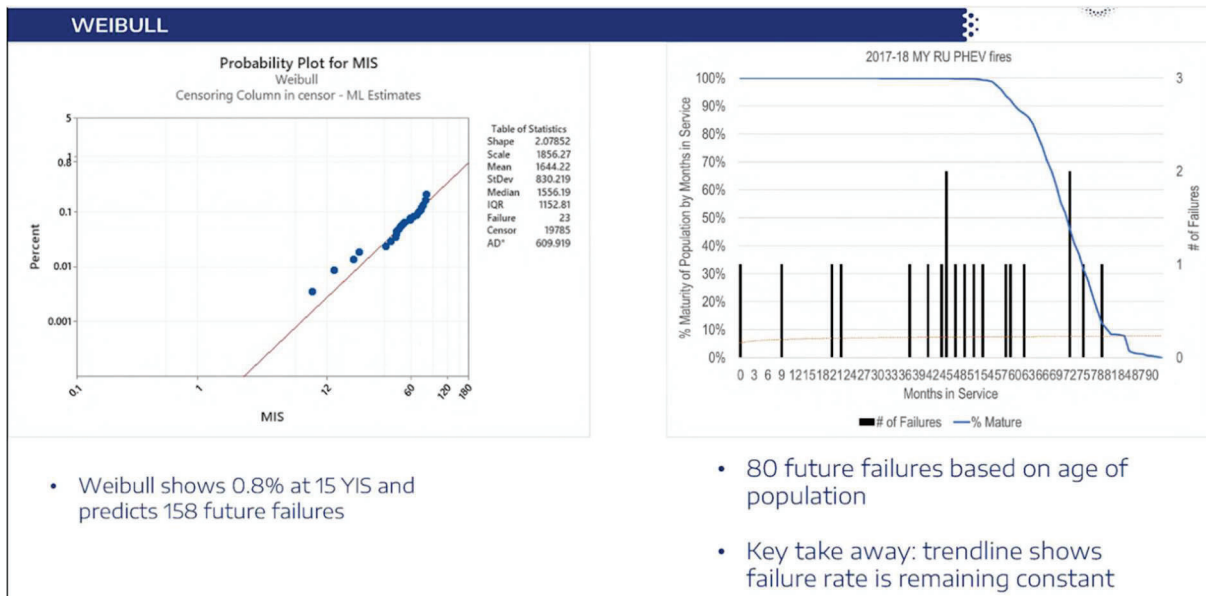
Figure 15. FCA analysis of projected failure (fire) rates.⁴²

FCA's analysis further states, "Weibull analysis shows 0.8%" (failure) "at 15 YIS" (years in service) "and predicts 158 future failures" (Figure 15).⁴⁰ A Weibull distribution is a statistical analysis tool to model a

broad range of random variables, largely related to time to failure or time between events, in a probability distribution. FCA's analysis further predicted "80 future failures based on age of population" and provided the "key take away" that the "trendline shows failure rate is remaining constant" (Figure 15).⁴¹
